The 5th International Forum on the Decommissioning of the Fukushima Daiichi Nuclear Power Station

Efforts to Ensure Safety in Decommissioning (No.2) Spent Fuel Removal

November 1, 2021

Fukushima Daiichi Decontamination &
Decommissioning Engineering Company
Tokyo Electric Power Company Holdings, Inc.

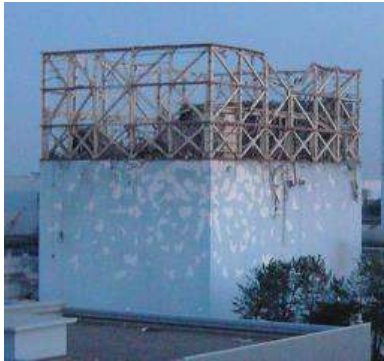
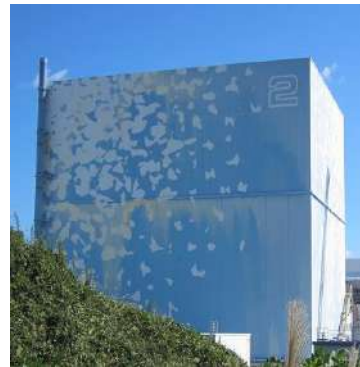
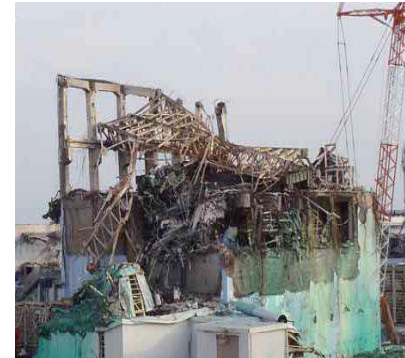
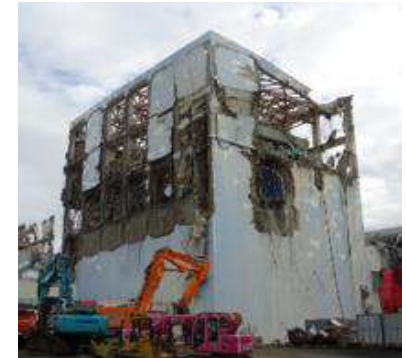
Situation of stored fuel assemblies in SFP (at time of 2011 disaster)

Stored fuel assemblies: 392

Stored fuel assemblies: 615

Stored fuel assemblies: 566

Stored fuel assemblies: 1,535

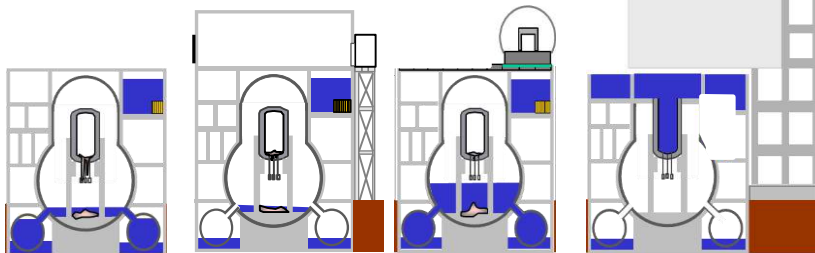
Overview of pool fuel removal

Transport/Storage
Multi purpose cask

On-Site transport cask

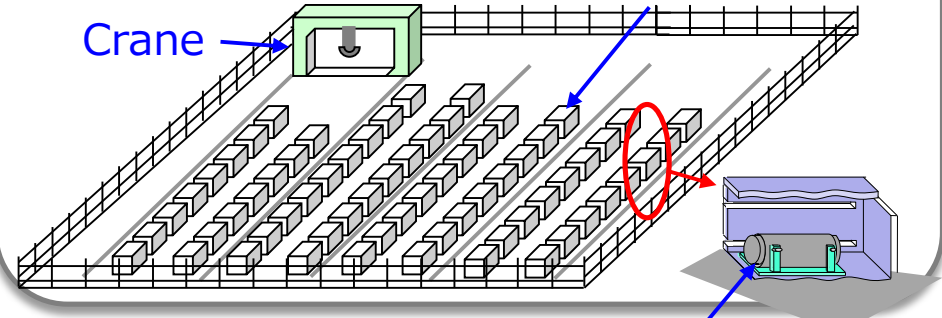
Temporary dry cask storage facility

Crane

Concrete module

Dry storage cask **TEPCO**

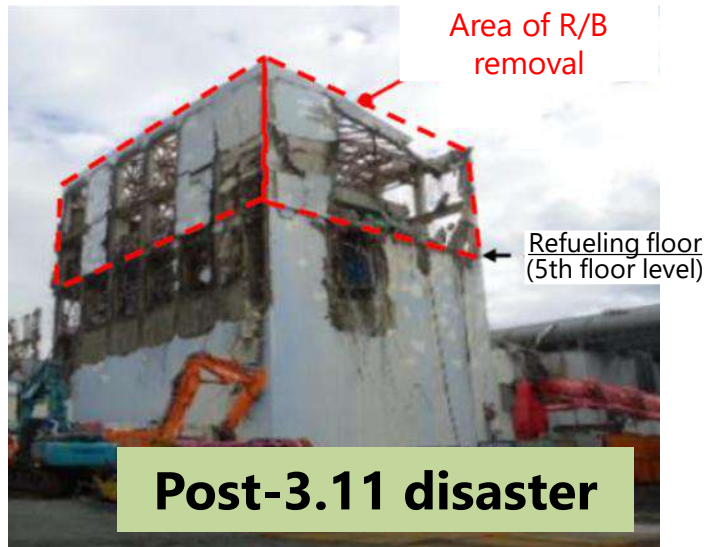
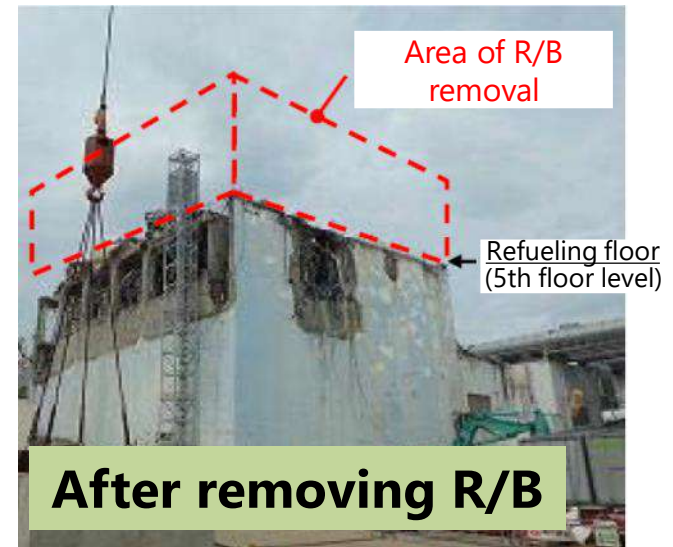
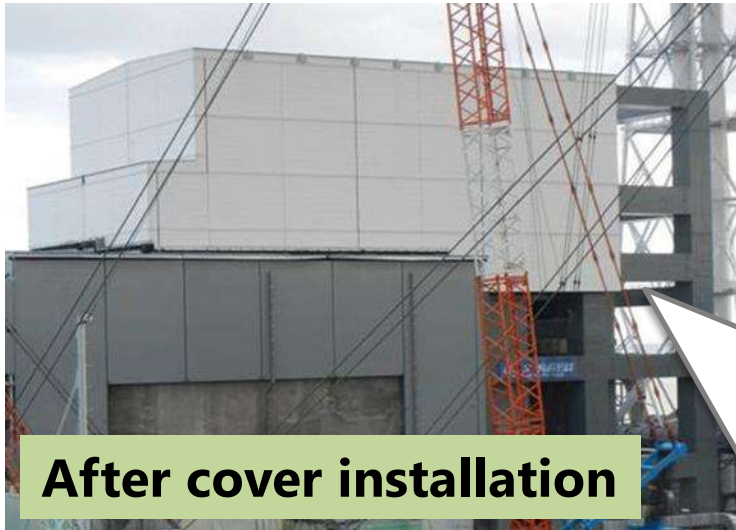
Dismantling upper part of R/B and installing cover (1)

- Despite a hydrogen explosion, Unit 4 had **lower radiation dose levels** than other units
- Materials left at the top floor were **removed by manned operations**, as such operations were possible.
- The explosion damaged the building framework above the uppermost floor. **The upper part of the R/B was dismantled by manned heavy machinery for dismantling.**

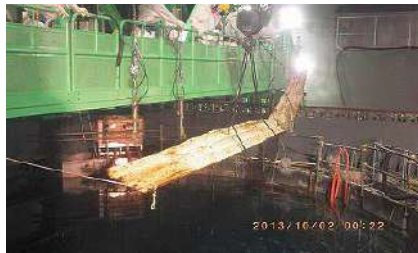
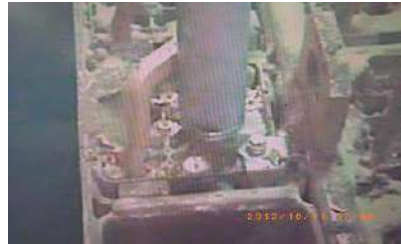
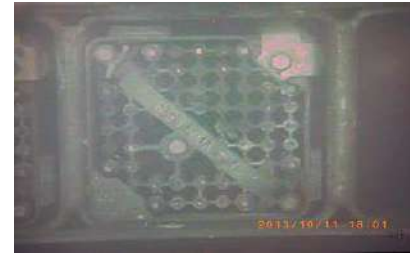
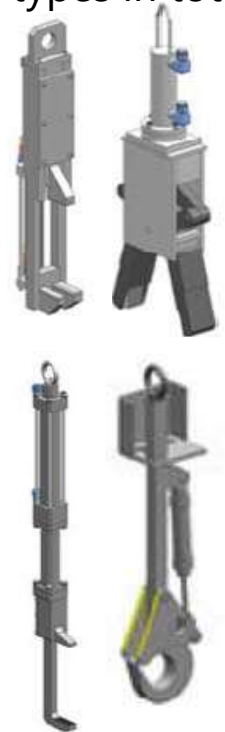
Rubble was retrieved piece by piece, using jigs of various sizes/shapes

Retrieval of large rubble

Rubble suction

After suction

Rubble retrieval jigs
(21 types in total)

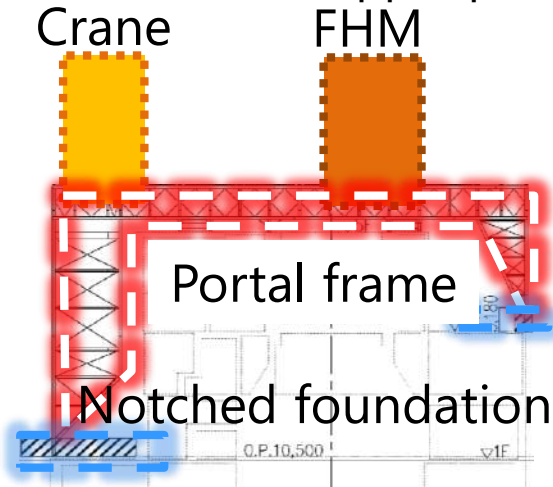
Fuel removal cover

Portal frame and notched foundation adopted

- Reduce load on upper part of R/B

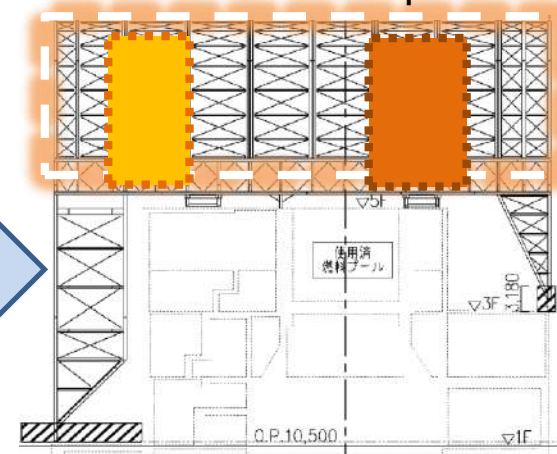
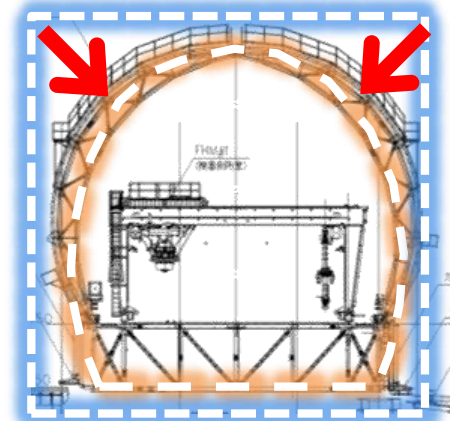
Weight reduction required

Trussed structure and dome roof adopted

Reduced 100 t by remodeling from blue to orange

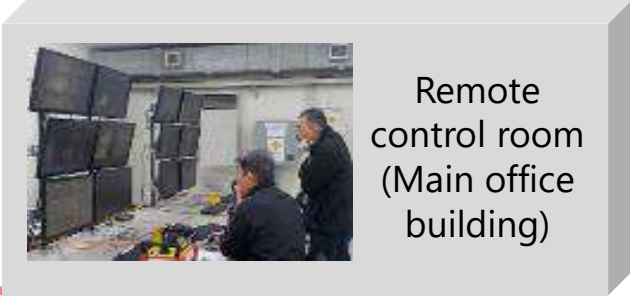
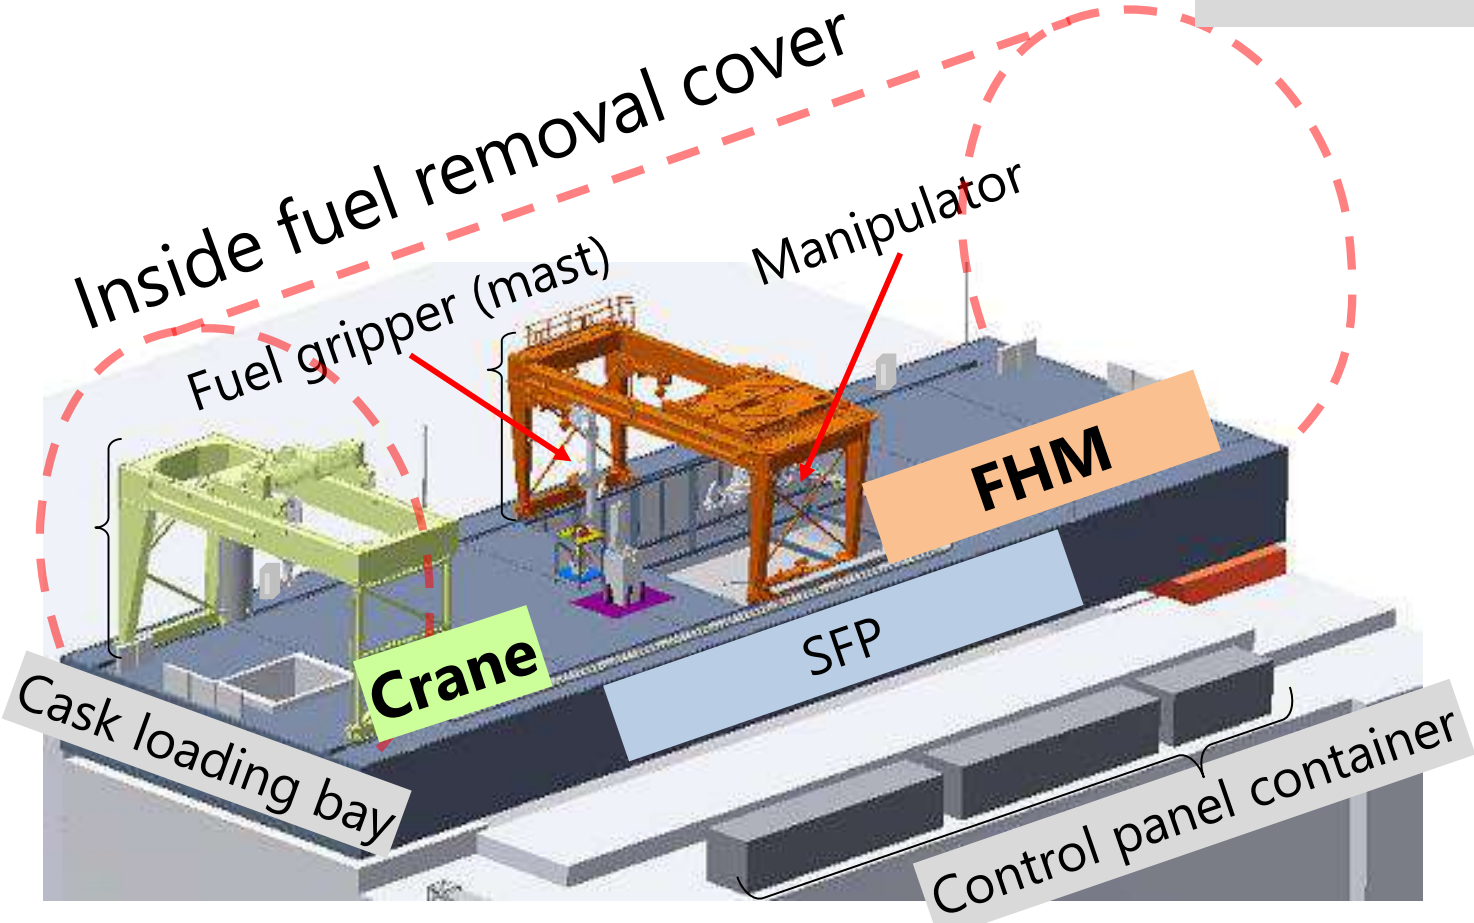
Fuel removal system (Entirety)

Fully-remote-controlled fuel removal
[First-ever achievement in the world]

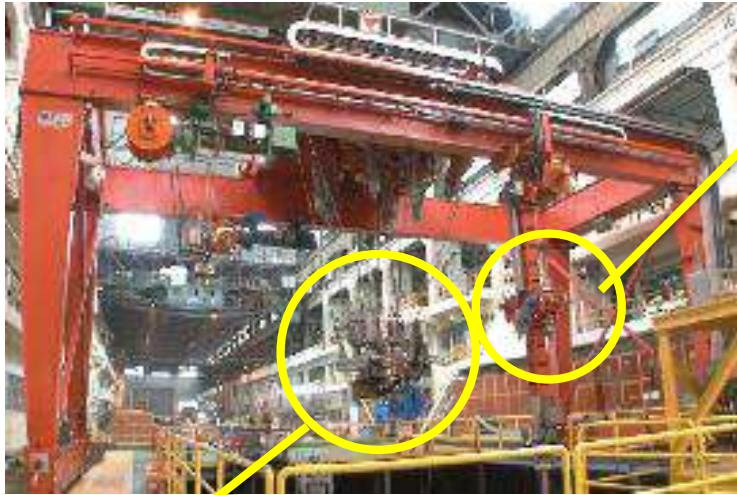
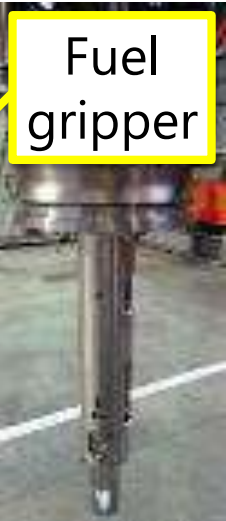
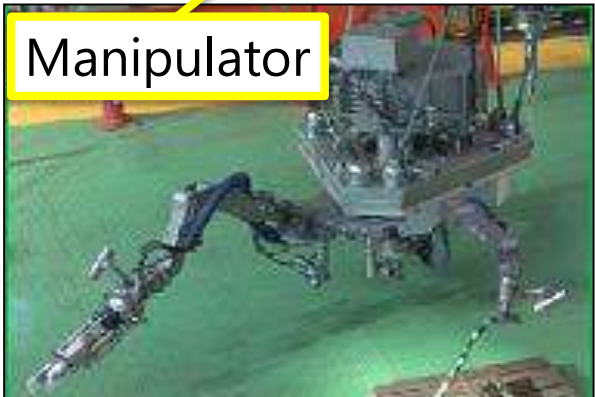
FHM

- Moves fuel with fuel gripper
- Removes rubble with manipulator

Fuel gripper

Manipulator

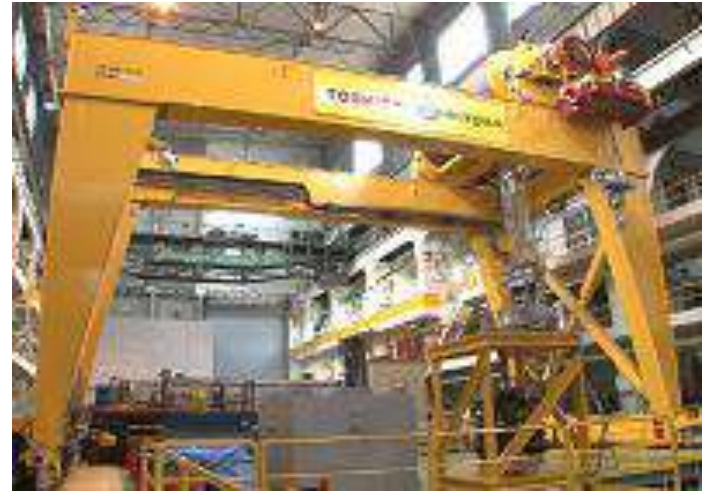
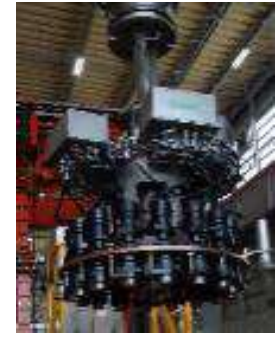
Crane

- Tightens transport cask lid
- Lifts transport cask

Transport cask lifting accessory

Lid tightener

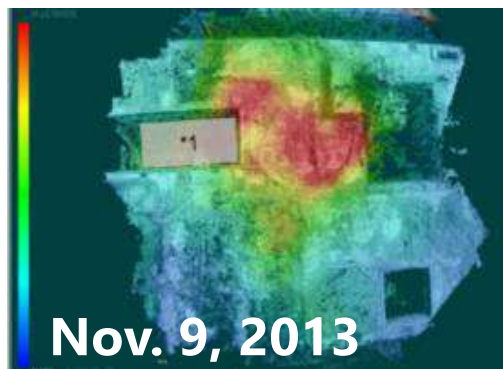
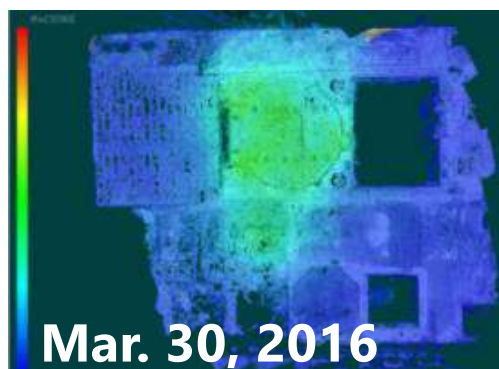
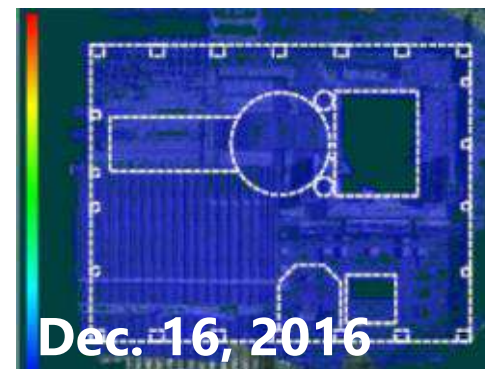
- The plan was to remove fuel from late FY2014 (in Roadmap announced in 2011)
- Delay in rubble retrieval, decontamination, shielding -> **Fuel removal started 4 years behind schedule**

- Manned work was impossible before rubble removal, because of high dose
- With rubble retrieval, decontamination, and shielding, dose levels dropped from 920 mSv/h to 0.5 mSv/h

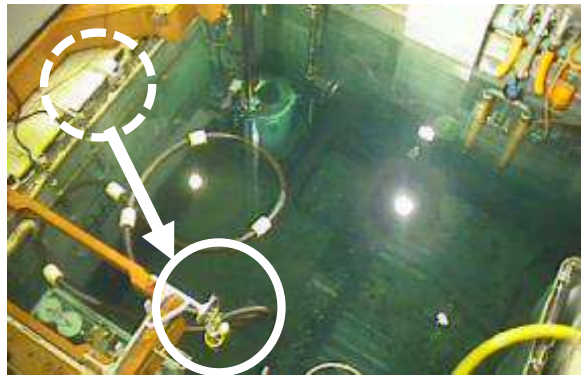
(2) Moved fixed location of suction hose out of fuel transport route

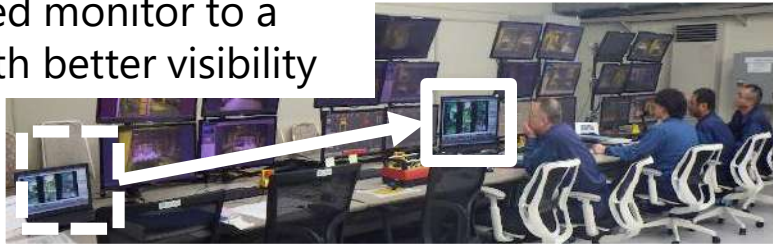
(2) Moved monitor to a place with better visibility

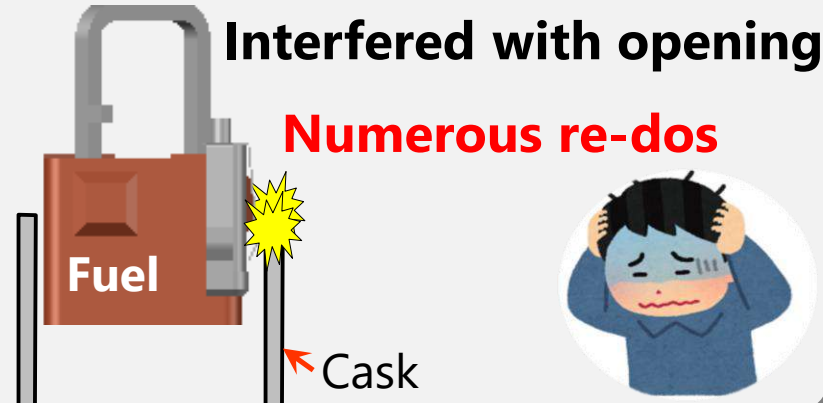
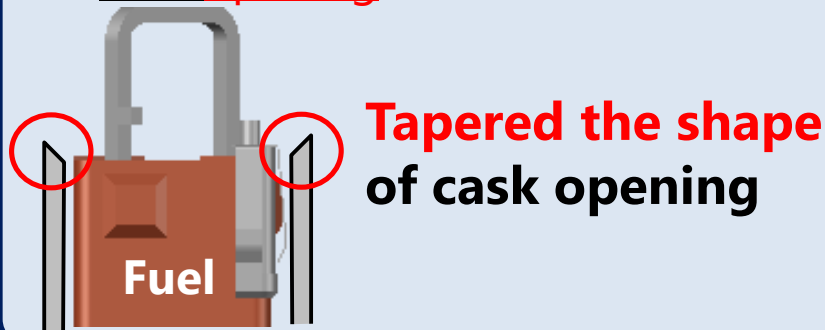
Changed loading steps

Original plan: **Interfered** with cask

After review: **Changed shape of cask opening**

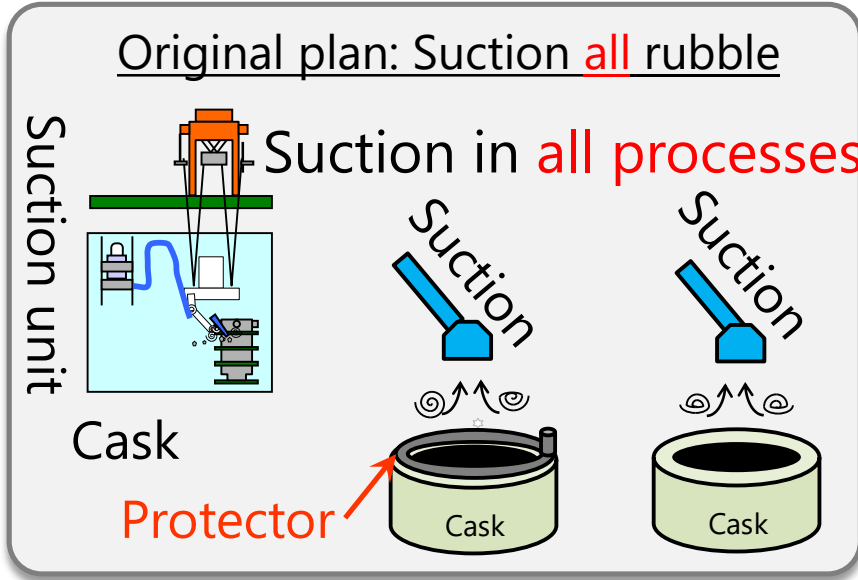
KAIZEN
(Changed tools)

Suction: Meant for **sealing function**

Sealing function: Only **flange surface**

Suction: Unnecessary for **protector surface**

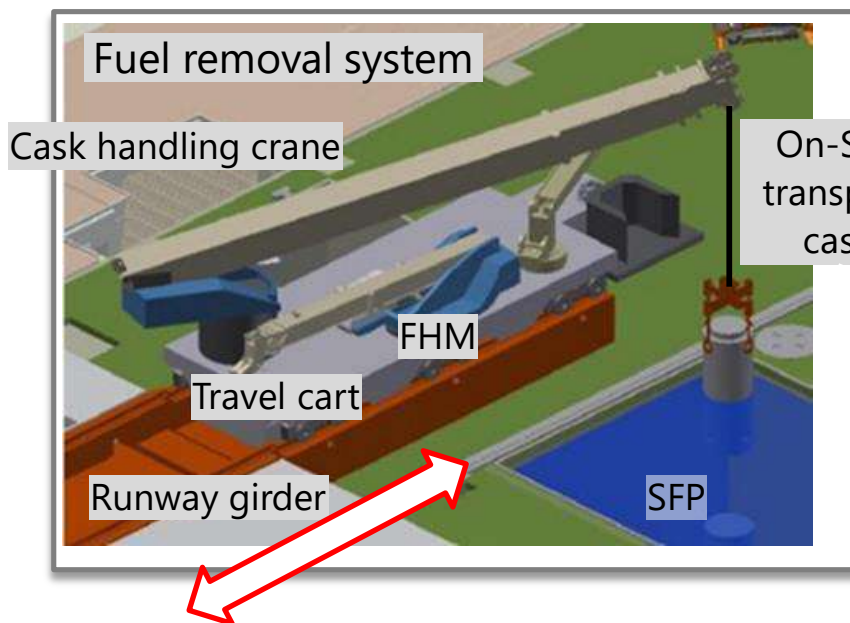
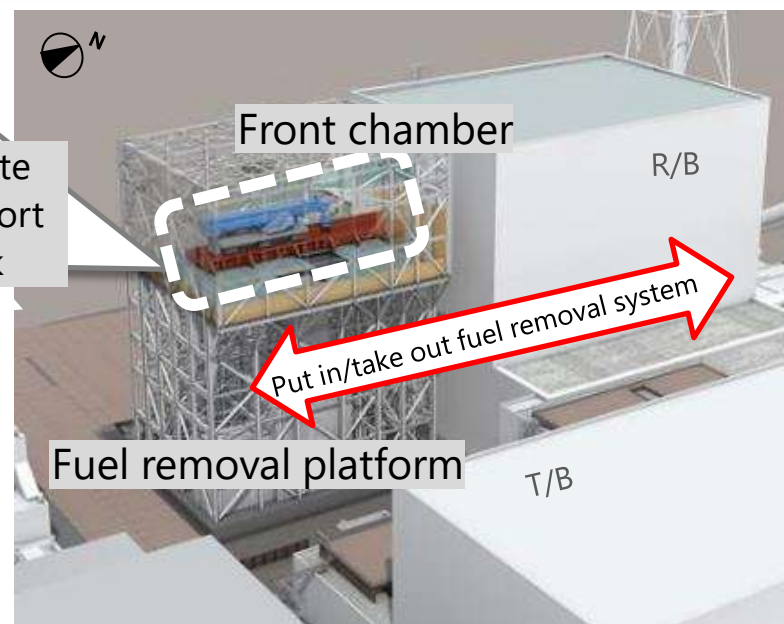
Fuel removal strategy for Unit 2

- Capitalize on existing building and install minimal wall opening
Take in/out fuel removal system through wall opening: **Prevent contamination spread**
- Install fuel removal system after decontamination/shielding
Remotely fuel removal: **Reduce exposure**

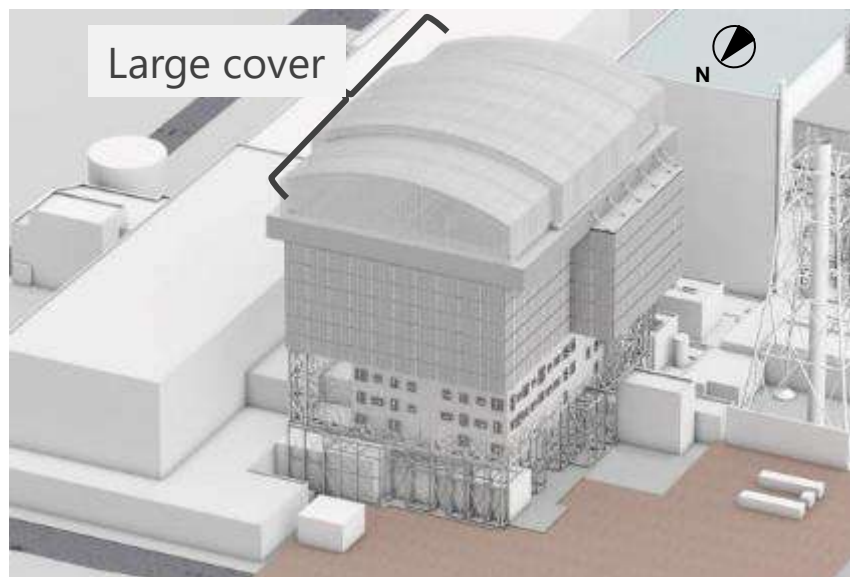
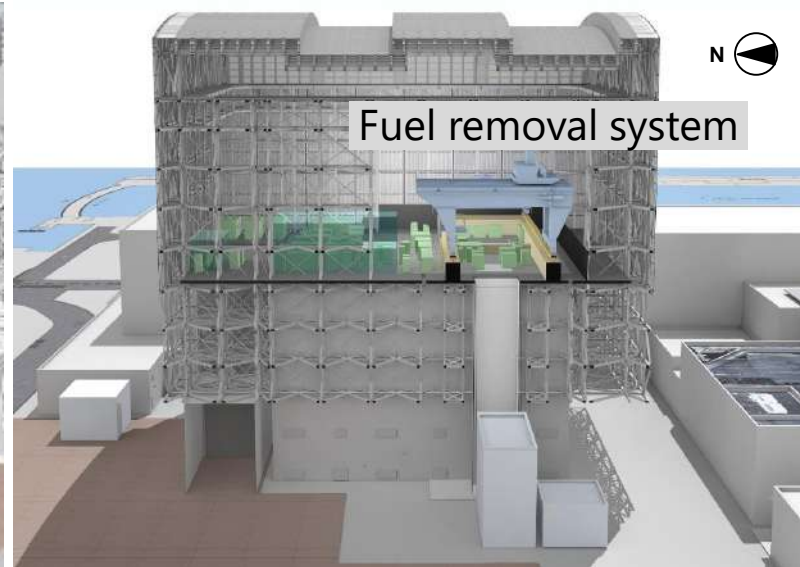
Fuel removal strategy for Unit 1

- Install large cover for top of R/B: **Prevent contamination spread**
- In order to **reduce exposure**, rubble retrieval and decontamination/shielding before install fuel removal system and fuel removal by local operation
- How to safely remove the fuel is a challenge, because some fuel rods have damage in their cladding tube
